Inspection of Polyethylene Fusions and Electrofusions

Dr. Ken Oliphant, Dr. Peter Angelo and Patrick Vibien, JANA Corporation
Dr. Andy Burns and Dr. Michail Kalloudis, Impact Solutions

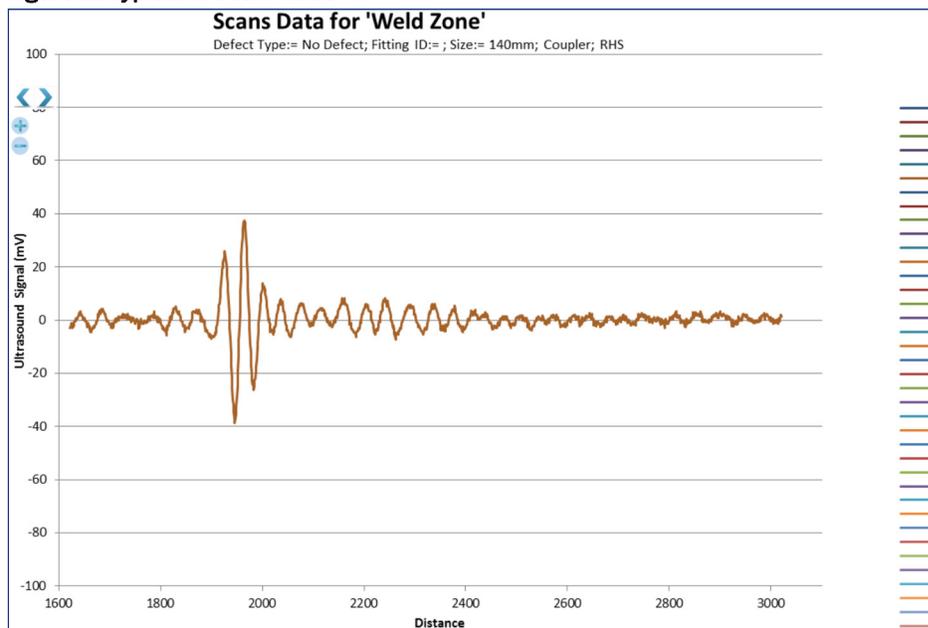
The goal of ultrasonic inspection is to “see” the hidden regions of an electrofusion joint in order to assess joint quality. There are two primary ways that ultrasound can be used on plastic pipe joints. The first method is to use a pulse-echo system, using a single probe transducer and presentation of results in the form of an A-Scan (time domain trace). This is a very simple and inexpensive system using only one probe and modest electronics. Figure 1 shows a typical A-Scan trace—an X, Y plot showing energy received (Y axis) vs time (X axis). Information from the material interfaces and other reflections are contained in the sinusoidal wave shape.

Figure 1: Typical A-Scan Trace

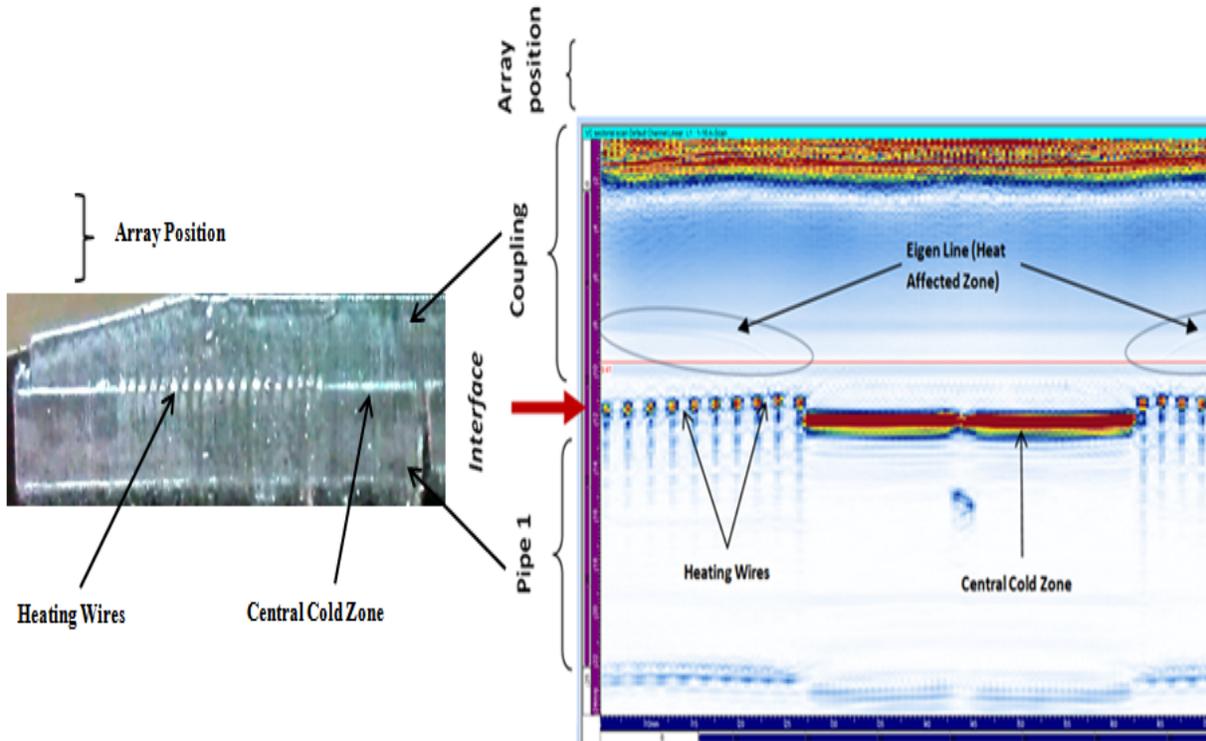
The second method is to use a phased array, comprising multiple piezoelectric elements which can be individually addressed and controlled. Here, electronic scanning is carried out, where a subset of elements are excited, the relative phase of the excitation that is applied to each element will cause the ultrasonic energy to be focused to a particular depth in the sample being interrogated—usually to the weld interface. The output from the phased array is referred to as a B-Scan. A typical B-Scan output is shown in Figure 2 (using a 128 element probe system).

Figure 2: Typical B-Scan Trace

The B-Scan output appears as a picture of a section through the weld, with the reflections from the heating wires, material interfaces and other reflection points identified. The B-Scan technique is typically 10-20 times more expensive than the single probe, much larger to handle and requires an expert to interpret the results.

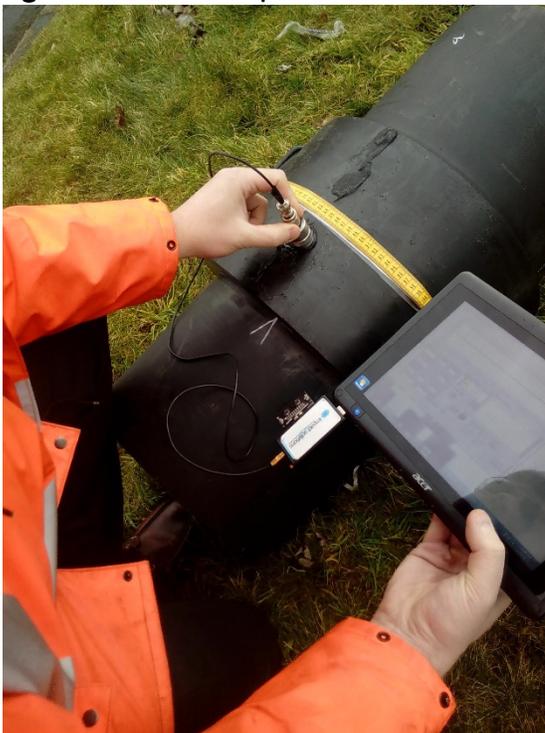
The developed tool is hand-held, rugged and can be connected to a portable tablet or laptop (Figure 3). Given the very low profile of the end of the probe, it can be used in very tight areas and measure right up to shoulders, nipples and other molding irregularities. The probe needs to be in direct contact with the surface, which is achieved using a coupling gel.

One requirement for A-scan technology is that the probe is held vertically to the weld to ensure maximum sound reflection. Even small deviations from the vertical can result in poor results, which may be one reason why A-Scans have not become popular. This issue has been resolved by the development of a patented software solution that ensures results cannot be taken until the probe is in the vertical position, confirming that the operator obtains an accurate assessment of the joint.

Figure 3: Ultrasonic Inspection Tool

The tool is simple to use as it is compact, provides a green/red pass fail output and its patented technology ensures that accurate readings are taken. Analysis of a 4" electrofusion coupling takes 5 - 15 minutes.

The A-Scan output—a string of numbers representing the power received by the receiver in time increments—is processed to provide a green/red light for a pass or a fail of the joint. It is also possible to determine the type of void and, hence, the most likely cause of the joint failure so that corrective action can be taken. Roughly thirty readings are taken each second. Repeatability is excellent so averaging of the spectra is not required.

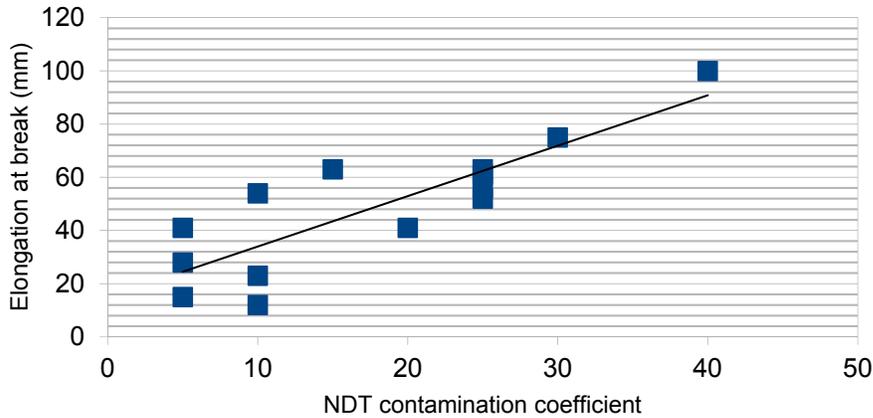
As discussed previously, the most difficult defect to detect in NDT assessments is mud contamination. Figure 4 provides a comparison of the NDT contamination coefficient (determined by the analysis software based on the spectral trace) and the elongation at break in the WIS pull test for a series of field joints with varying levels of contamination. There is a very good correlation, so the A-Scan NDT

methodology is able to detect not only contamination but also the actual level of contamination with good accuracy. This correlation can be used to set pass/fail criteria for an inspected joint based on the observed contamination coefficient.

Figure 4: Elongation and Break versus NDT Correlation Coefficient
